## BAT FATALITY AT A WIND ENERGY FACILITY IN THE WESTERN CAPE, SOUTH AFRICA

Jonathan Barry ARONSON\*, Alicia Jessica THOMAS, Stacey Leigh JORDAAN

Gaia Environmental Services, 20 Elizabeth Lane, Constantia, Cape Town, 7800, [info@gaiaenvironmental.co.za](mailto:info@gaiaenvironmental.co.za), +27 (0)21 794 6826.

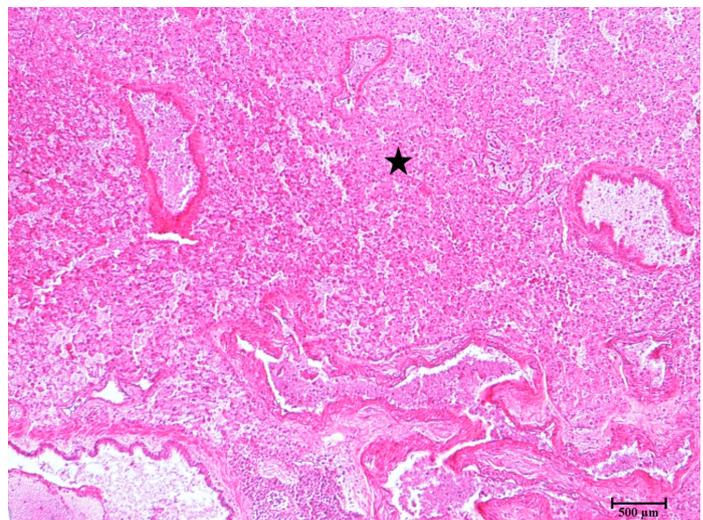
**Figure 1.** Histological section of a lung from the *Neoromicia capensis* killed at the DWFNDP, stained with haematoxylin and eosin (100x). The black star indicates severe intra-alveolar haemorrhage. See Figure 3 in Grodsky *et al.* (2011) to contrast with a healthy bat lung.

Visual inspection revealed that the bat had no major external injuries, broken bones or signs of having been struck by a turbine blade. Necropsy showed that the bat had food in its digestive tract indicating that it had recently fed, eliminating starvation as a cause of death. This is consistent with the hypothesis that bats are attracted to wind turbines to feed on nocturnal insects that are themselves attracted to turbines (KUNZ *et al.* 2007; RYDELL *et al.* 2012). The bat's internal organs, except the lungs, all appeared healthy and the bat showed no signs of any pre-existing disease. Both lungs had obvious pulmonary haemorrhaging and had collapsed. Although the lungs showed moderate to severe autolysis, marked congestion and haemorrhage of the entire section was clearly discernible, consistent with barotrauma (Figure. 1; see also BAERWALD *et al.* 2008; ELSAYED and GORBUNOV, 2007). Large areas (80%) of the lung showed filling of the alveoli with granular and proteinaceous material indicating protein-rich oedema.

Although post-mortem examination of the bat's lungs suggests that barotrauma may have been the likely cause of death, this is difficult to isolate from salvaged bat carcasses (GRODSKY *et al.* 2011; ROLLINS *et al.* 2012). Barotrauma is usually characterized by lung oedema, haemorrhage, vascular congestion, interstitial bullae and lung collapse (BAERWALD *et al.* 2008; ELSAYED and GORBUNOV, 2007). However, these are also post-mortem artefacts occurring during the natural process of decomposition and can therefore mask the direct effect of barotrauma. In addition, certain traumatic injury (such as being struck by a wind turbine blade) can also lead to oedema and haemorrhage in the lungs further confounding the diagnosis of pulmonary barotrauma (ROLLINS *et al.* 2012). Since, for logistical reasons, we were unable to examine the bat using radiology as in GRODSKY *et al.* (2011) and ROLLINS *et al.* (2012), we also cannot exclude direct collision with a wind turbine blade as the proximate cause of death in this case. GRODSKY *et al.* (2011) detected 33% fewer broken bones using visual inspection compared to radiology results and not all bats show external signs of direct collision with turbine blades. Therefore, the visual inspection of the carcass that we performed may not have been adequate to provide evidence of any fatal broken bones, and hence wind turbine induced mortality. Carcass search studies should be undertaken systematically and use multiple complimentary diagnostic procedures including visual inspection, radiology, necropsy and histopathology to accurately infer bat mortality at wind energy facilities (GRODSKY *et al.* 2011; ROLLINS *et al.* 2012). Knowledge of the etiology of bat mortality at wind energy facilities can lead to better mortality estimates, improved management and more efficient mitigation

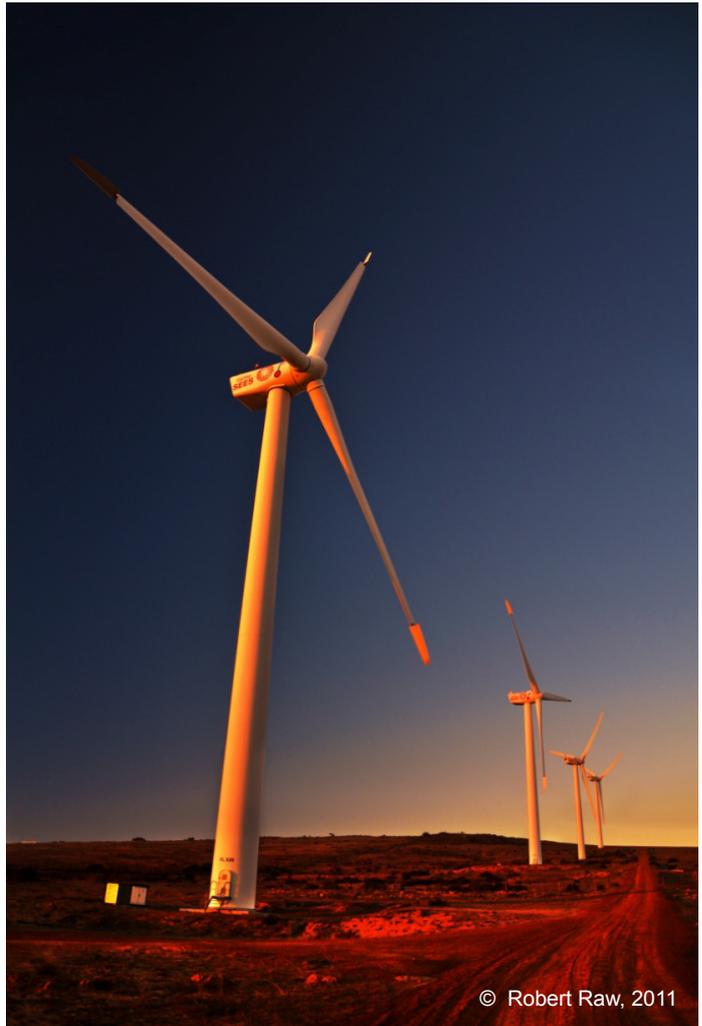
**Above.** The four 1.3 MW wind turbines at the DWFNDP. The turbines are 82 m from base to blade tip. Photo taken on 16 April 2011.

The DWFNDP consists of four 1.3 MW turbines with 50 m high towers and 32 m long blades and is currently the largest operating wind energy facility in South Africa. The turbines are positioned in a row ascending a hill that has an average slope of approximately 10%. Land use around the facility is primarily agricultural including sheep farming and wheat crops and most vegetation is low growing with few trees. We searched each turbine once a week from 2 August until 29 September 2011 (nine searches in total), the spring migratory period in South Africa when some bat species begin to move from winter hibernacula to summer maternity roosts (MILLER-BUTTERWORTH *et al.* 2003). We were unable to extend the study into summer or autumn due to financial and time constraints. All searches were started less than two hours after sunrise to reduce the effects of carcass removal by scavengers on the search day.

The result of this study is significant because it confirms that wind energy facilities in South Africa do have the potential to kill bats, and could have implications for the conservation of bats in the region. At 82 m tall, the turbines at the DWFNDP are much smaller compared with those that are planned for construction across the country. Since bat fatalities are known to increase with increasing heights of wind turbines (BARCLAY *et al.* 2007), the risk to bats is therefore likely to increase as construction of taller turbines commences. With the large number of proposed wind energy facilities around the country, especially in the Eastern and Western Cape where bat fatalities have now been reported (DOTY and MARTIN, 2012; this study), rigorous research is needed both pre- and post-construction to assess, predict and minimise the potential impact of such facilities on bats and other fauna in South Africa.

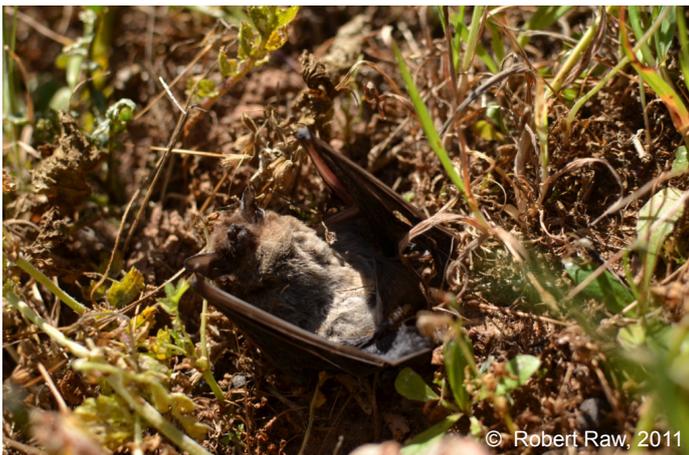
**Above.** The *Neoromicia capensis* carcass as we found it at the DWFNDP on 24 September 2011

We found one bat carcass during the 2-month study period identified morphologically as an adult female *N. capensis* according to TAYLOR (2000) and MONADJEM *et al.* (2010). The individual was found on 24 September 2011 at the second turbine in the row of four, towards the base of the slope. It was located approximately 30 m from the turbine base. We estimated the time of death to be the previous night because the carcass showed no external signs of decomposition. On the same day we also found the carcass of a Cape Spurfowl (*Pternistis capensis* (J.H. Gmelin, 1789)) less than 10 m from the base of the third turbine. The carcass had no obvious external signs of being attacked or killed by a predator or of decomposition.

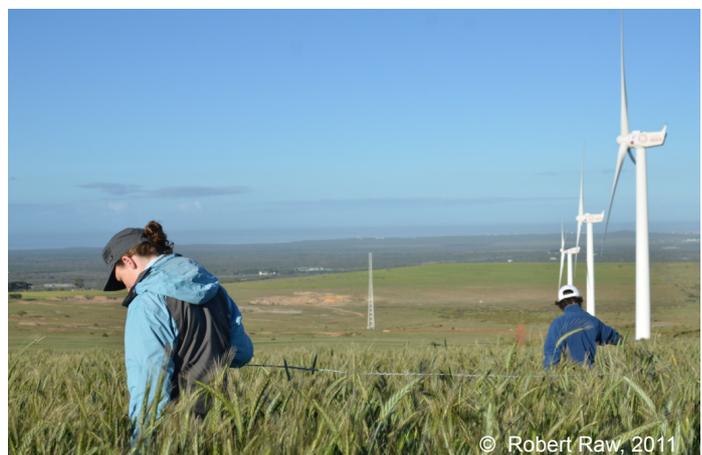
**Above.** JBA and AJT search through wheat fields for bat carcasses beneath wind turbines at the DWFNDP on 24 September 2011. Carcasses can be difficult to locate in dense vegetation such as this.

To locate bat carcasses, two searchers starting 60 m from a turbine and standing 7 m apart, walked spiral transects around the turbine, searching 3.5 m either side of the 'transect line' [following BAERWALD and BARCLAY (2009)]. The order in which the turbines were searched and the starting direction (i.e. N, S, E or W) was alternated between searches. Depending on the starting direction, between four and six spirals were walked around each turbine during each transect. The direction searchers walked around the turbines (i.e. clockwise or anti-clockwise) was switched every four visits. When a carcass was found, we recorded species, age (ANTHONY, 1988), sex, degree of decomposition, external condition of the carcass and distance from the turbine base. To determine the cause of death we inspected any carcass we found visually to search for lacerations and fatal injuries such as broken bones. We then performed a gross necropsy and carefully removed the lungs, examining them under a dissecting microscope. Subsequently, the Histology Laboratory in the Department of Human Biology, University of Cape Town, prepared sections of the lungs to enable histopathological examination of cell structure and tissue damage.
